**PORT OF PORTLAND
MARINE TERMINAL 1
HOUSE 105 AND 106**

**REGULATED BUILDING MATERIALS SURVEY
(For Reference Only)**

**PBS Project Number
8415.27**

March 1997

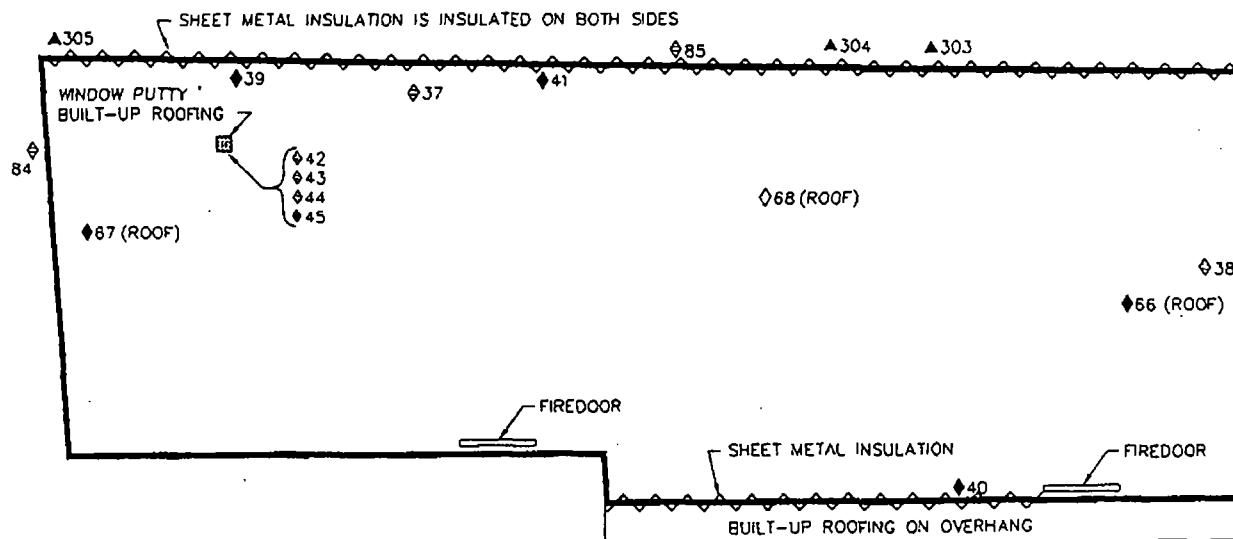
ASBESTOS SURVEY PLAN

- THIS DRAWING IS DIAGRAMMATIC. IT IS FOR GENERAL INFORMATION AND SAMPLE LOCATION.
- ACCESSIBLE SPACES WERE SURVEYED FOR SUSPECT ASBESTOS MATERIALS. WHEN OBSERVED THE MATERIALS WERE NOTED ON THE DRAWINGS.
- BUILT-UP ROOFING IS FRIABLE AND NON-INTACT.
- PAINT TESTED IS FLAKING.
- PAINTED WOOD COMPONENTS PASSED TOLP TEST.

HOUSE 105

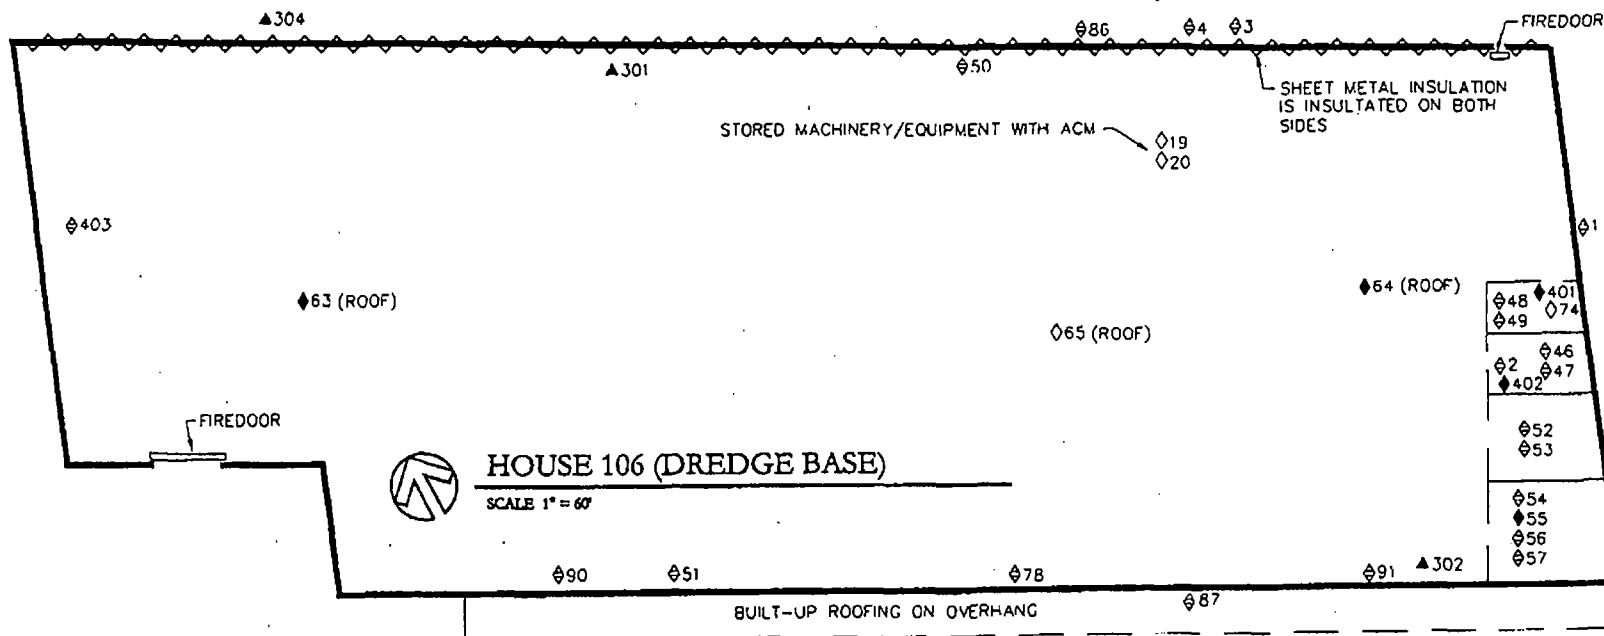
ASBESTOS SURVEY PLAN
 PORT OF PORTLAND
 TERMINAL NO.1 - HOUSE 106

1. THIS DRAWING IS DIAGRAMMATIC. IT IS FOR GENERAL INFORMATION AND SAMPLE LOCATION.
2. ACCESSIBLE SPACES WERE SURVEYED FOR SUSPECT ASBESTOS MATERIALS. WHEN OBSERVED THE MATERIALS WERE NOTED ON THE DRAWINGS.
3. BUILT-UP ROOFING IS FRIABLE AND NON-INTACT.
4. PAINT TESTED IS FLAKING.
5. PAINTED WOOD COMPONENTS PASSED TCLP TEST.
